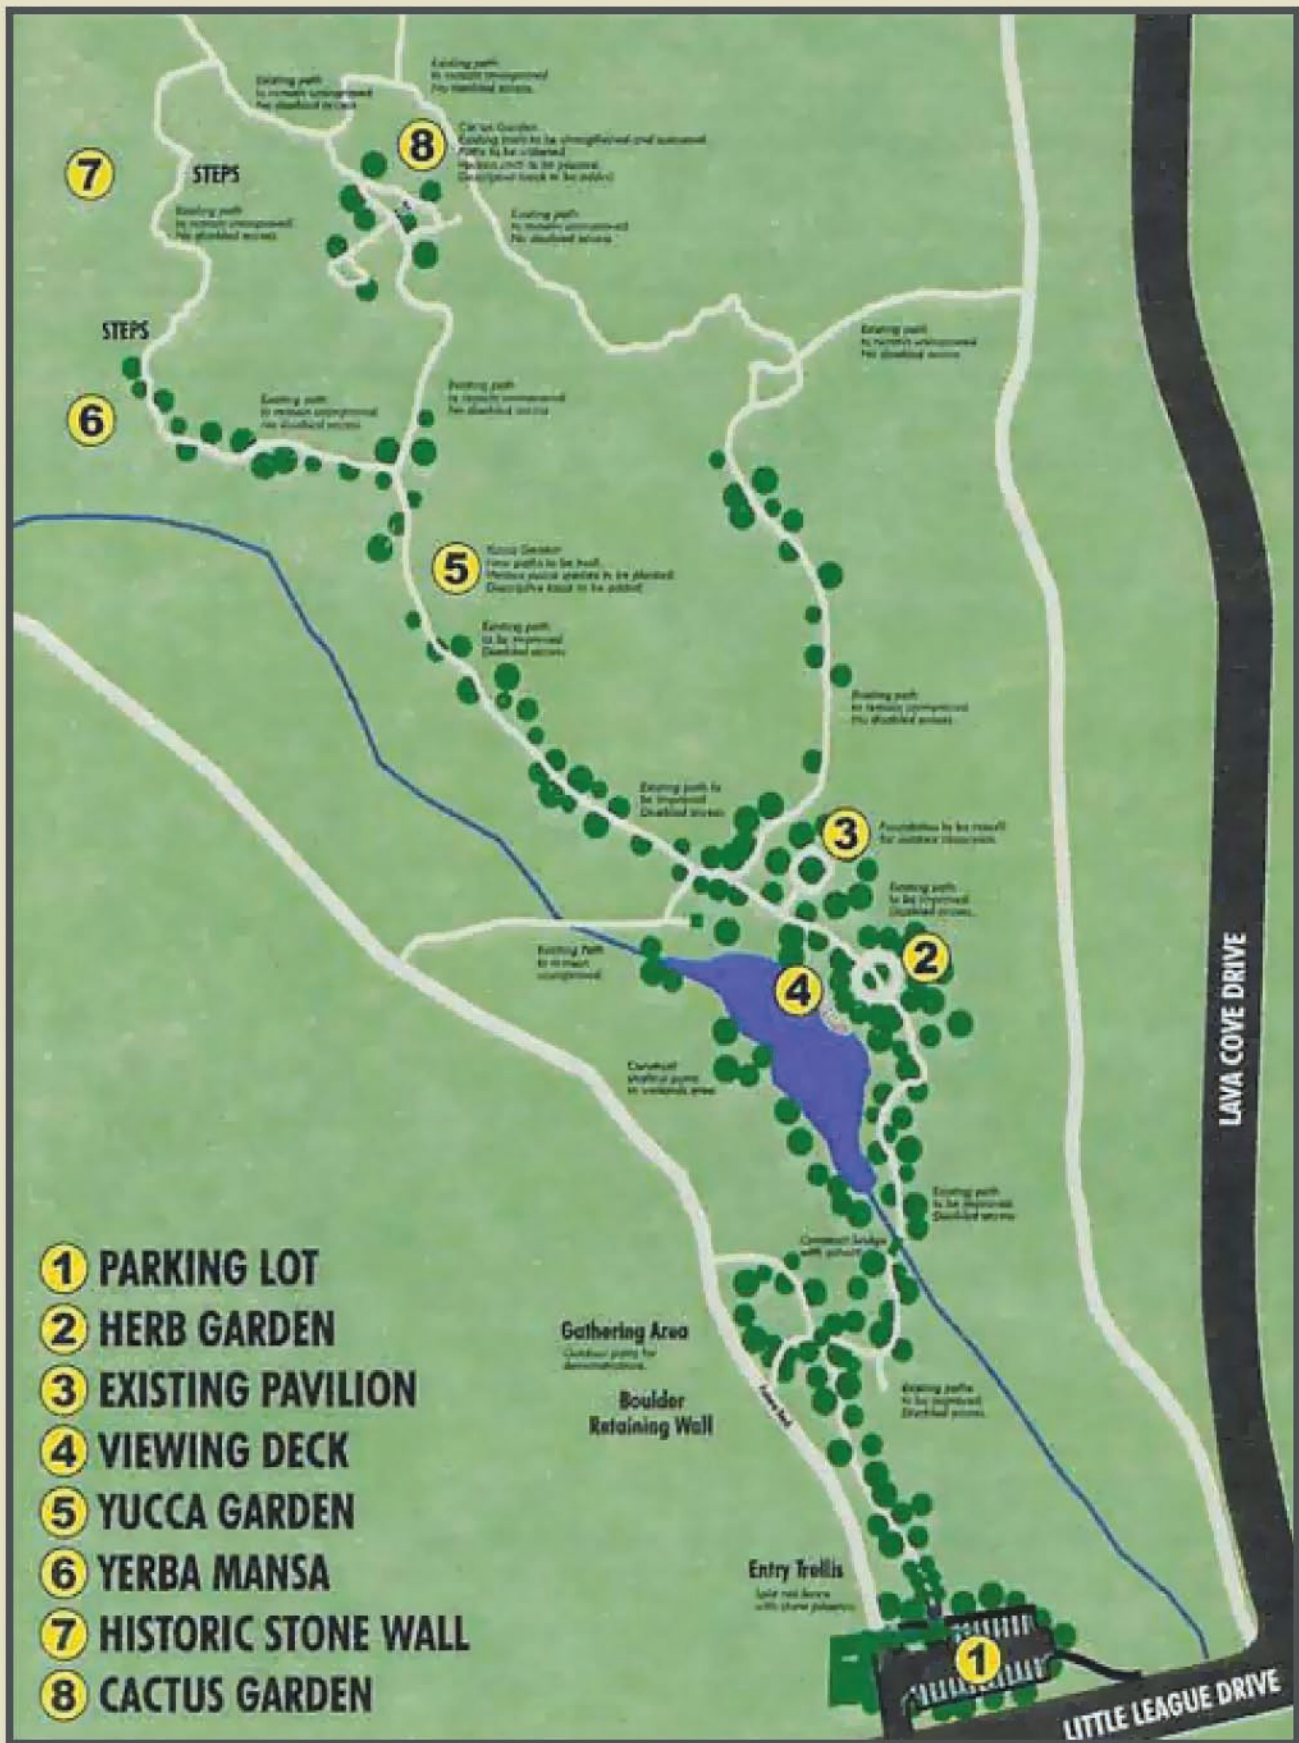
- ① PARKING LOT
- ② HERB GARDEN
- ③ EXISTING PAVILION
- ④ VIEWING DECK
- ⑤ YUCCA GARDEN
- ⑥ YERBA MANSA
- ⑦ HISTORIC STONE WALL
- ⑧ CACTUS GARDEN

Gathering Area
Outdoor space for demonstrations.

Boulder Retaining Wall

Entry Trellis
Solid red fence with stone pilasters.

Cactus Garden
Existing trees to be photographed and removed. Paths to be installed. Yucca and to be planted. Descriptive text to be added.

Yucca Garden
New paths to be installed. Yucca plants to be planted. Descriptive text to be added.

Existing path to be improved. Disabled access.

Foundation to be raised for outdoor classroom.

Current asphalt path to be removed.

Concrete bridge with archway.

Existing paths to be improved. Disabled access.
